## US HIGHWAY 385 BRIDGE A-28-P OVER SOUTH PLATTE RIVER, COLORADO

## US HIGHWAY 385 BRIDGE A-28-O OVER SOUTH PLATTE RIVER, COLORADO

## US HIGHWAY 385 BRIDGE A-28-N OVER SOUTH PLATTE RIVER, COLORADO

## US HIGHWAY 385 BRIDGE A-28-M OVER SOUTH PLATTE RIVER, COLORADO

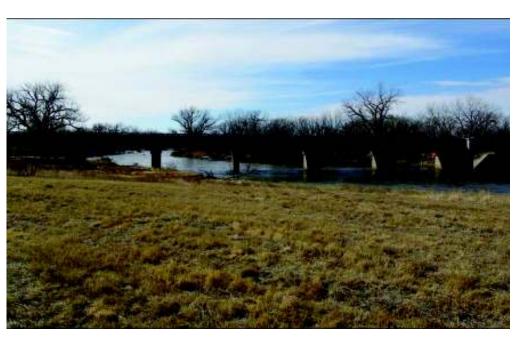
Figure 1. Bridge A-28-P over the South Platte River

Bridge A-28-P is located in Sedgwick County on US Highway 385 ML where the highway crosses the upper Colorado River. Figure 1 shows Bridge A-28-P over the Colorado River.

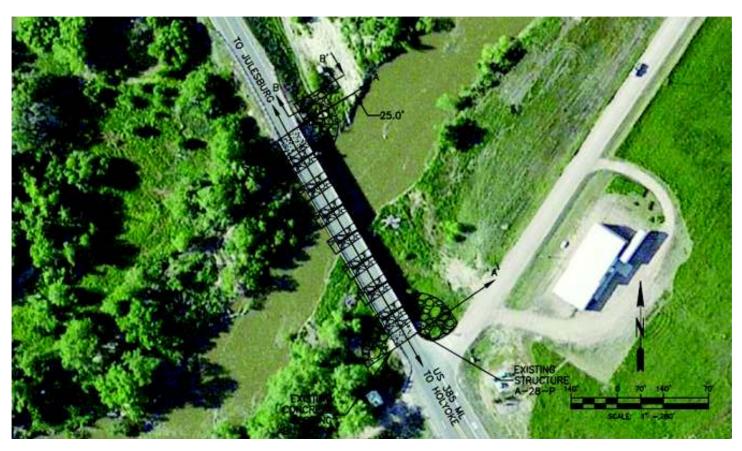
Figure 5. Plan view of Bridge A-28-P with recommended hydraulic scour countermeasure locations

Hydrau-Tech, Inc. developed preliminary riprap countermeasures at each of the critical locations on the bridge (left abutment, pier 2, pier 3, pier 4, pier 5, pier 6, pier 7, pier 8, and right abutment). Figure 5 shows an aerial image of structure A-28-P with the recommended scour countermeasure. Figure 6 shows a cross-sectional view of the structure with the recommended scour countermeasures and appropriate geometry. As a part of analysis, various cost estimates for alternative countermeasures were complete for comparison.

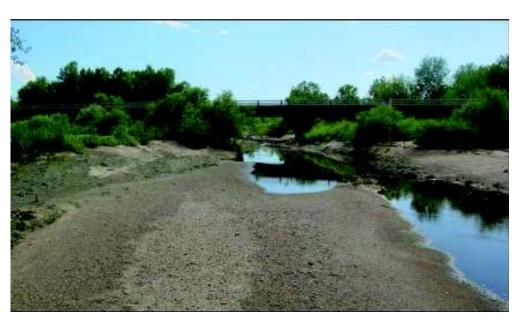
Figure 1. Bridge A-28-O over the South Platte River

Bridge A-28-O is located in Sedgwick County on US Highway 385 ML where the highway crosses the upper Colorado River. Figure 1 shows Bridge A-28-O over the Colorado River.

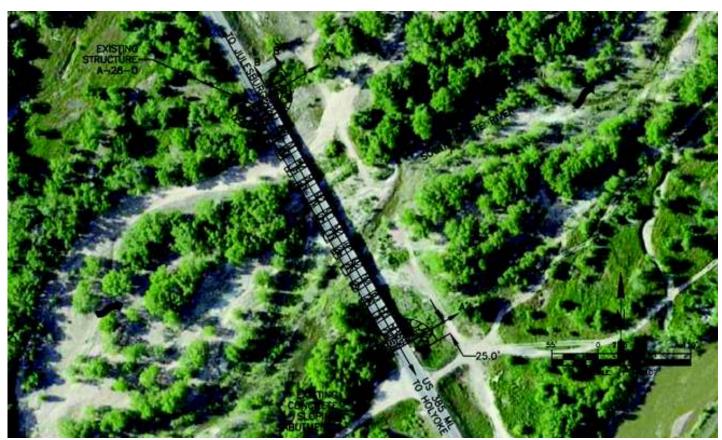
Figure 5. Plan view of Bridge A-28-O with recommended hydraulic scour countermeasure locations

Hydrau-Tech, Inc. developed preliminary riprap countermeasures at each of the critical locations on the bridge (left abutment, all piers, and right abutment). Figure 5 shows an aerial image of structure A-28-O with the recommended scour countermeasure. Figure 6 shows a cross-sectional view of the structure with the recommended scour countermeasures and appropriate geometry. As a part of analysis, various cost estimates for alternative countermeasures were complete for comparison.

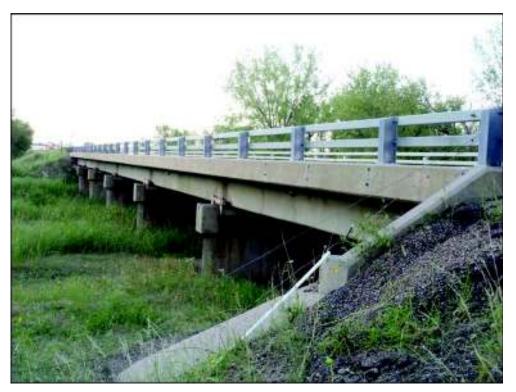
Figure 2. Bridge A-28-N over the South Platte River

Bridge A-28-N is located in Sedgwick County on US Highway 385 ML where the highway crosses the upper Colorado River. Figure 1 shows Bridge A-28-N over the Colorado River.

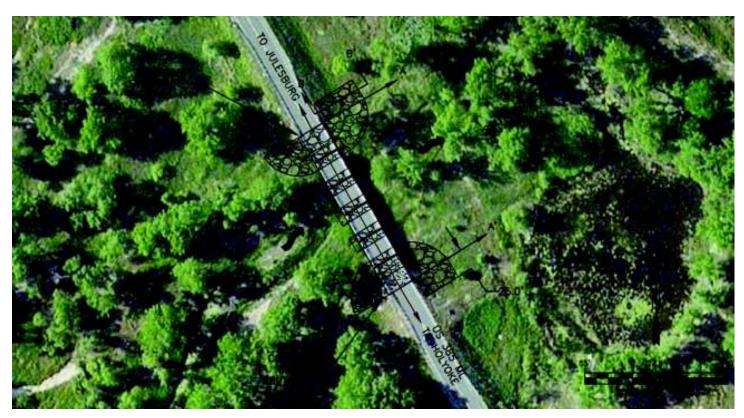
Figure 5. Plan view of Bridge A-28-N with recommended hydraulic scour countermeasure locations

Hydrau-Tech, Inc. developed preliminary riprap countermeasures at each of the critical locations on the bridge (left abutment, pier 2, pier 3, pier 4, pier 5, pier 6, and right abutment). Figure 5 shows an aerial image of structure A-28-N with the recommended scour countermeasure. Figure 6 shows a cross-sectional view of the structure with the recommended scour countermeasures and appropriate geometry. As a part of analysis, various cost estimates for alternative countermeasures were complete for comparison.

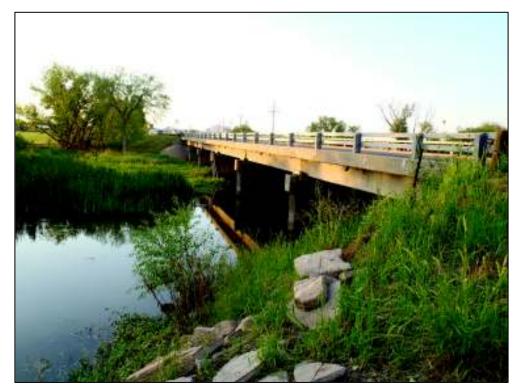
Figure 2. Bridge A-28-M over the South Platte River

Bridge A-28-M is located in Sedgwick County on US Highway 385 ML where the highway crosses the upper Colorado River. Figure 1 shows Bridge A-28-M over the Colorado River.

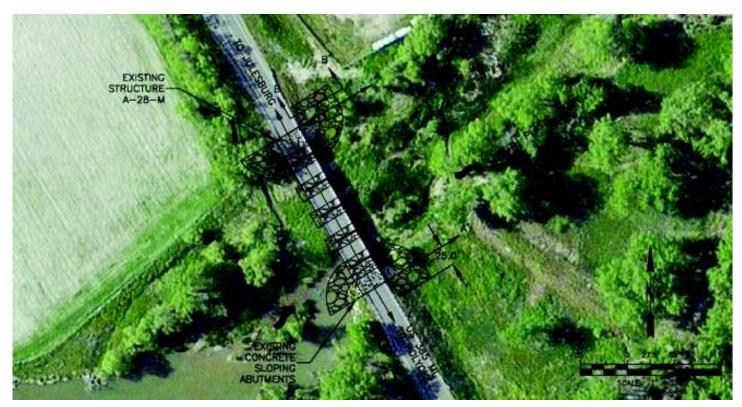
Figure 5. Plan view of Bridge A-28-M with recommended hydraulic scour countermeasure locations

Hydrau-Tech, Inc. developed preliminary riprap countermeasures at each of the critical locations on the bridge (left abutment, pier 2, pier 3, pier 4, pier 5, pier 6, and right abutment). Figure 5 shows an aerial image of structure A-28-M with the recommended scour countermeasure. Figure 6 shows a cross-sectional view of the structure with the recommended scour countermeasures and appropriate geometry. As a part of analysis, various cost estimates for alternative countermeasures were complete for comparison.
