# Hydrau-Tech, Inc.

# HYDRAU-TECH, INC.

## 2013 COLORADO FLOOD EMERGENCY HYDRAULIC RESPONSE

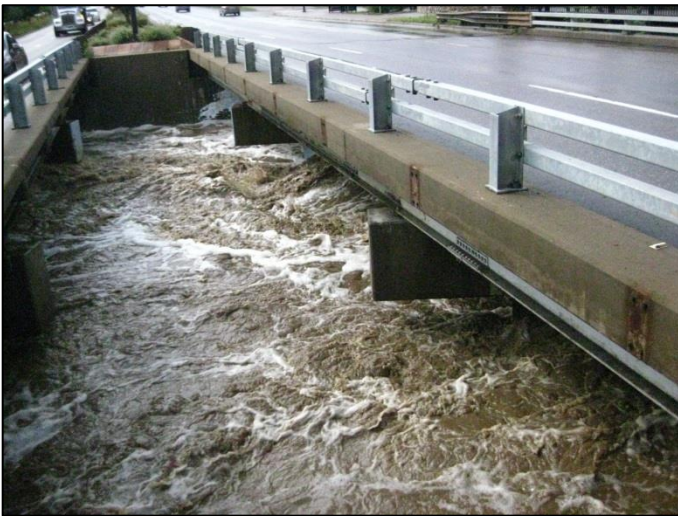
Boulder Creek at HW 36 during flood

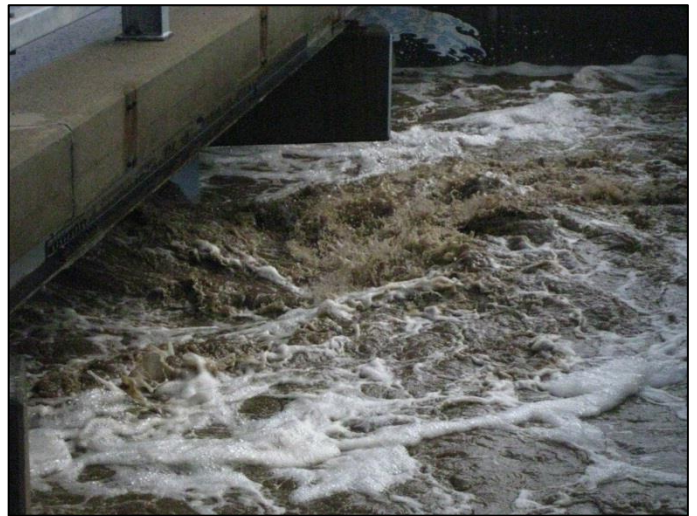
Boulder Creek at HW 36 flows between NB and SB bridges

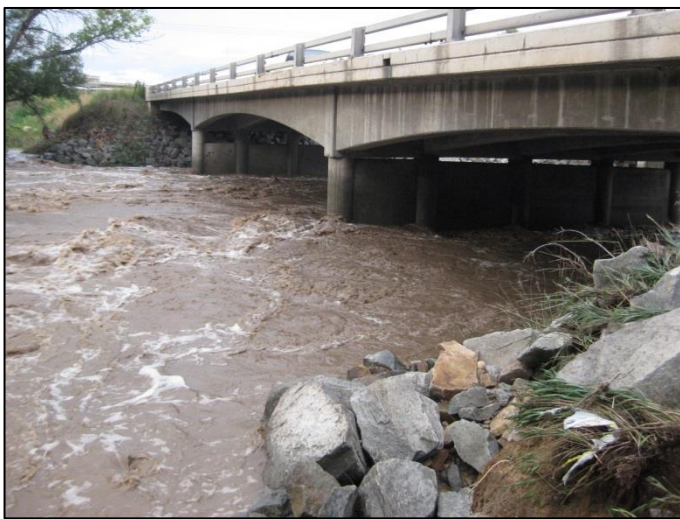
Big Thompson River at I-25, failed right abutment

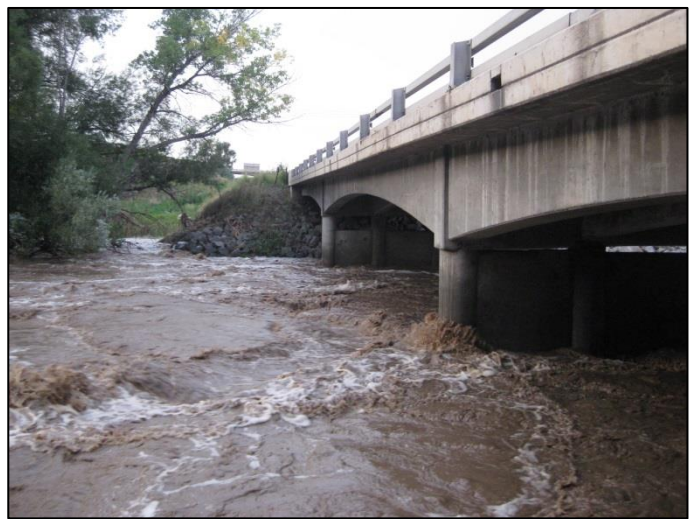
Big Thompson River at I-25, flows attacking pier

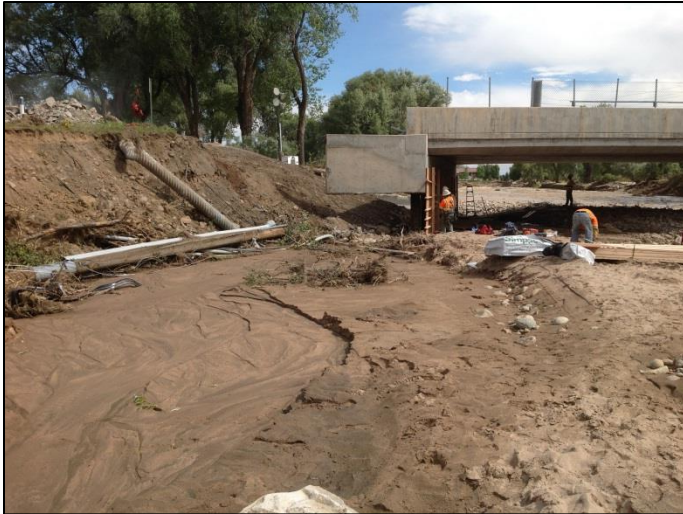
**Failed right abutment on HW 36 at Lyons**

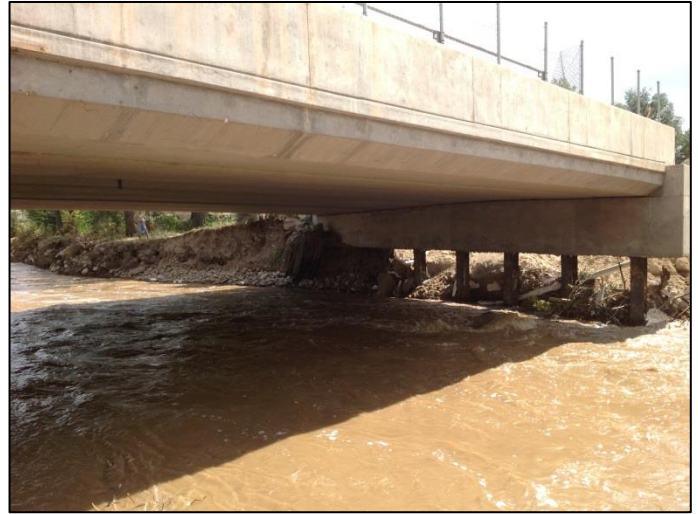
**Bridge on HW 36 at Lyons after flood**

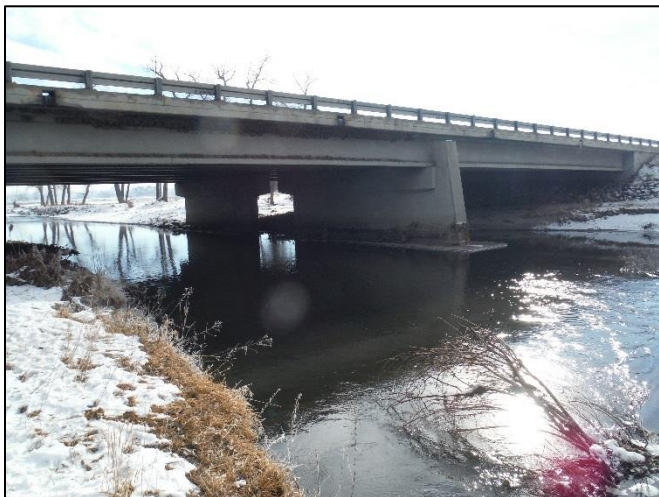
**Boulder Creek at US 287 after flooding**

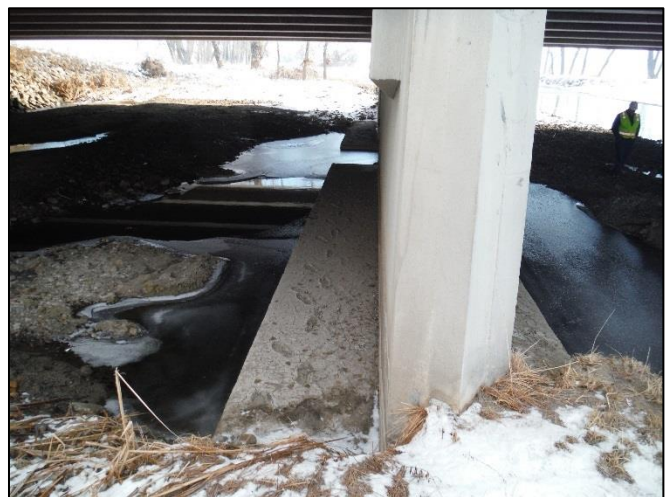
**Boulder Creek at US 287, pier scour at spread footers**

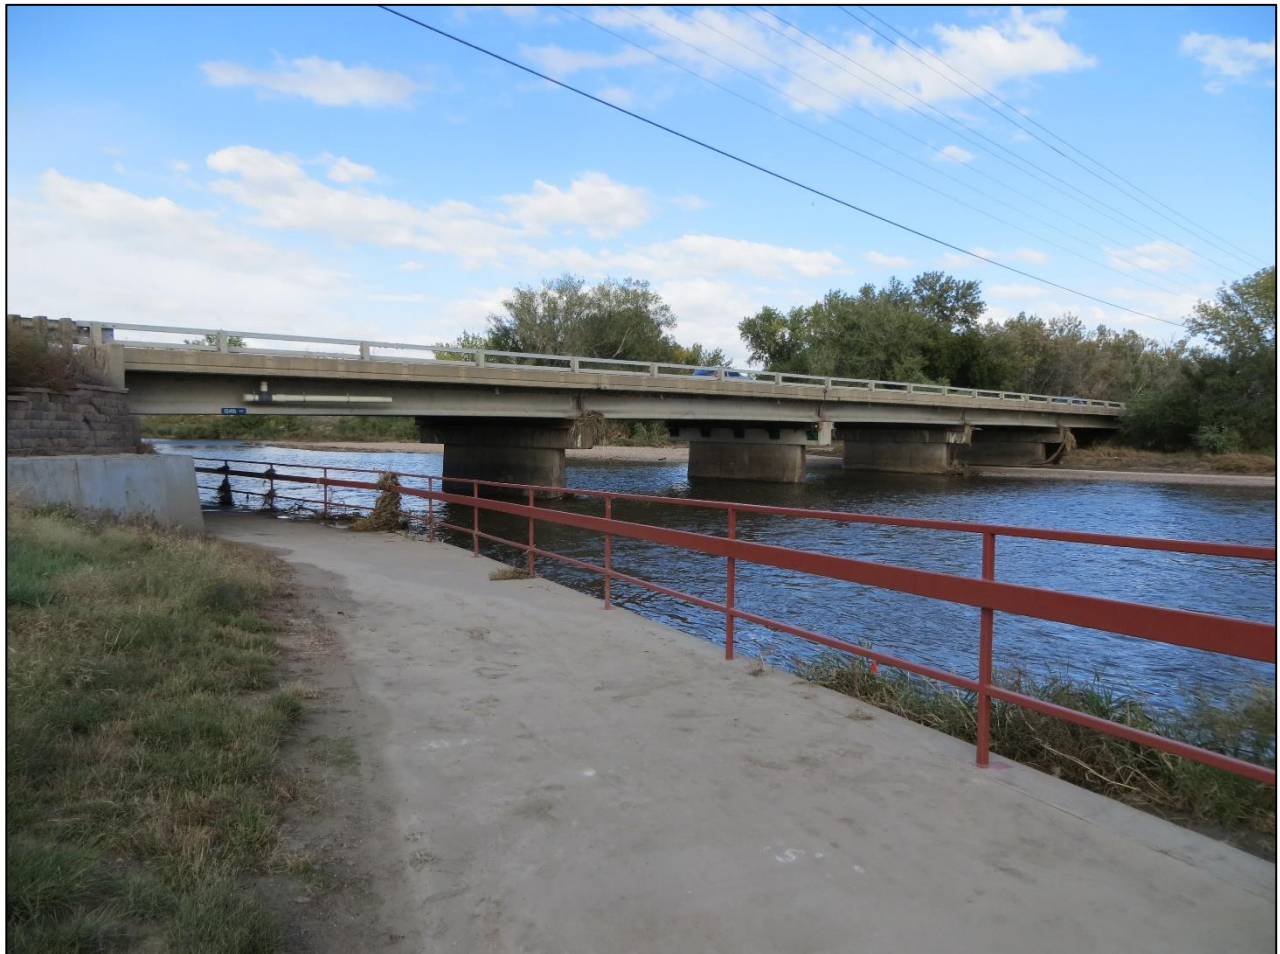
South Platte River at SH 287 44, minimal flood damage

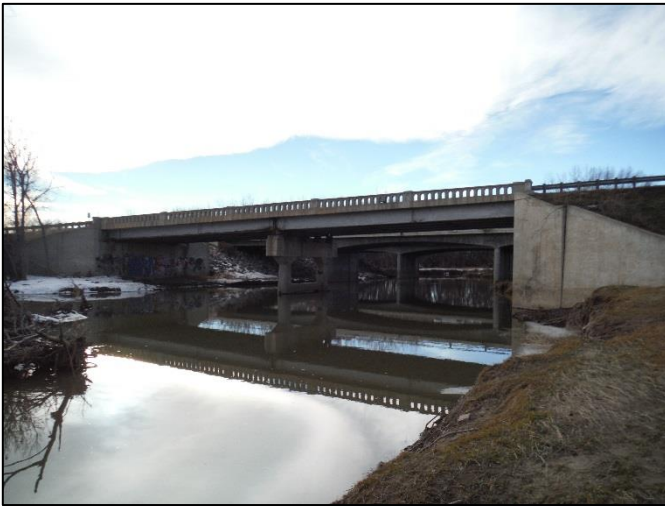
Pre-Construction

Category 3 bridges experienced moderate scour and required hydraulic survey and analysis prior to design of countermeasures. At structure C-17-F, the results of the hydraulic survey and analysis were used to design armoring countermeasures to repair severe scour and prevent future contraction scour, abutment and pier scour, and channel degradation.

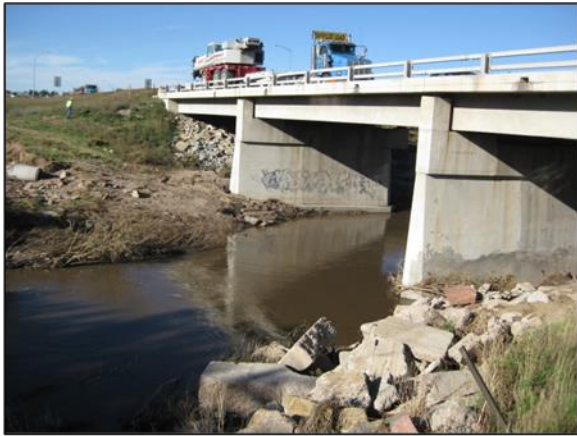
C-17-N over Little Thompson River – Scour at left embankment and downcutting between piers

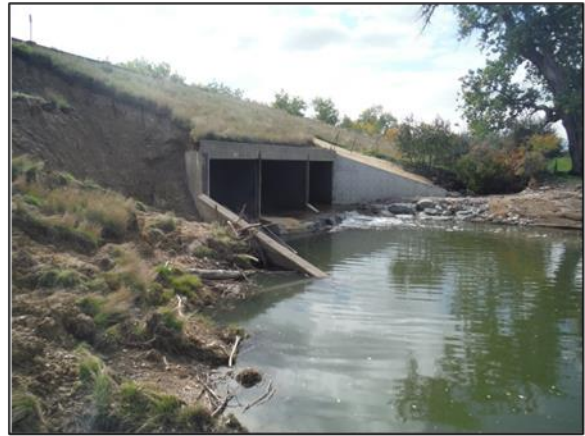
E-16-BC over Coal Creek – Significant scour hole downstream and from right abutment up to roadway

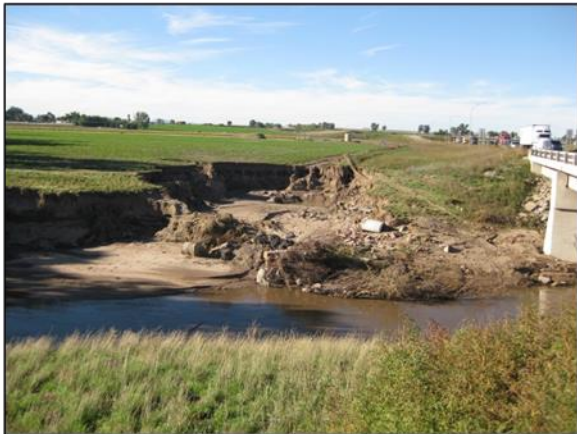
C-17-N over Little Thompson River – Channel and left embankment scour upstream of bridge

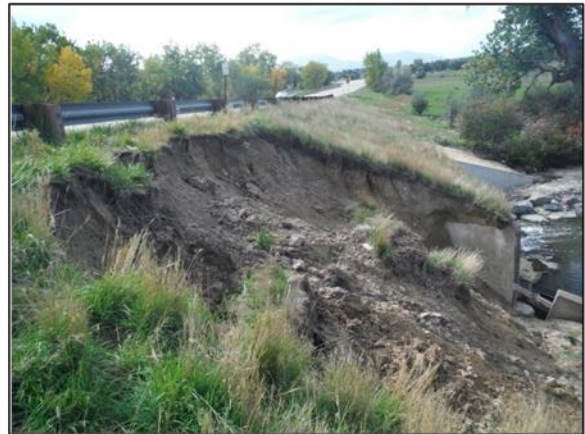
E-16-BC over Coal Creek – Scour hole from downstream right abutment to roadway

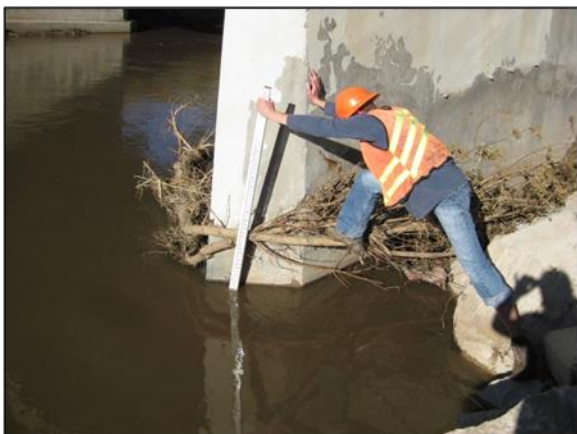
C-17-N over Little Thompson River – Exposed pier cap due to channel degradation and scour

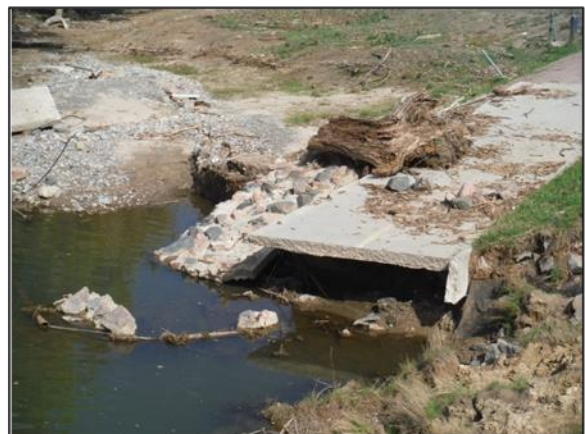
E-16-BC over Coal Creek – Scour damage to adjoining bike path

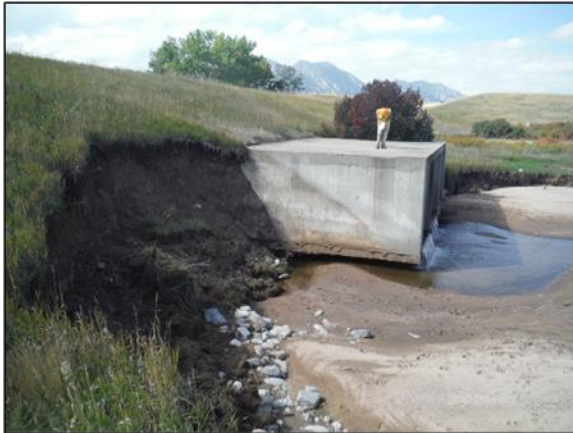
E-16-HB over Coal Creek - Scour at downstream right abutment

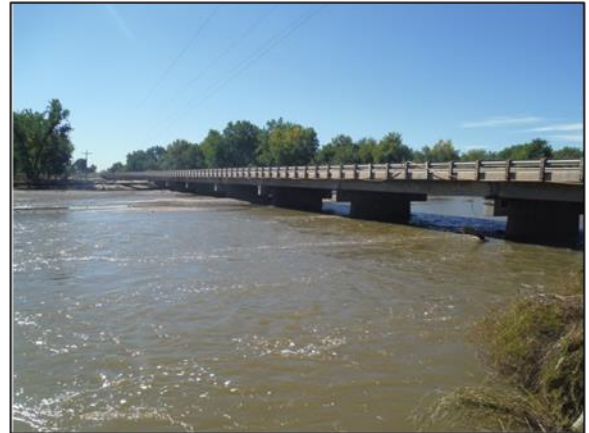
C-17-B over South Platte River – High flows and sediment discharges have changed channel morphology

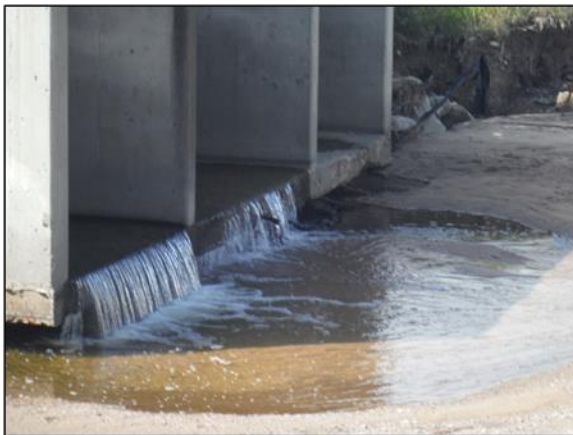
E-16-HB over Coal Creek - Scour at bridge outlet

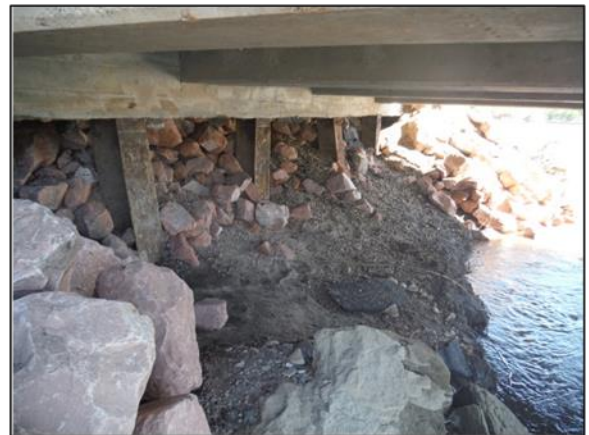
C-17-B over South Platte River – Exposed left abutment piles

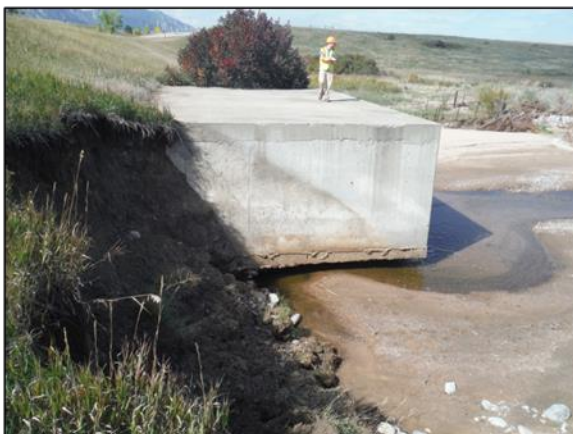
E-16-HB over Coal Creek – Downstream right abutment scour and undermining of structure

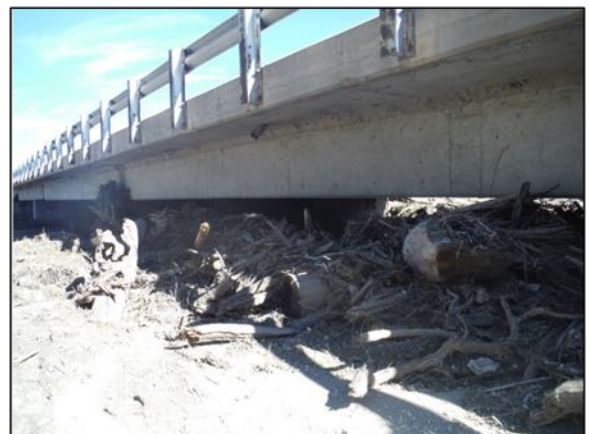
C-17-B over South Platte River – Debris accumulation up to low girder

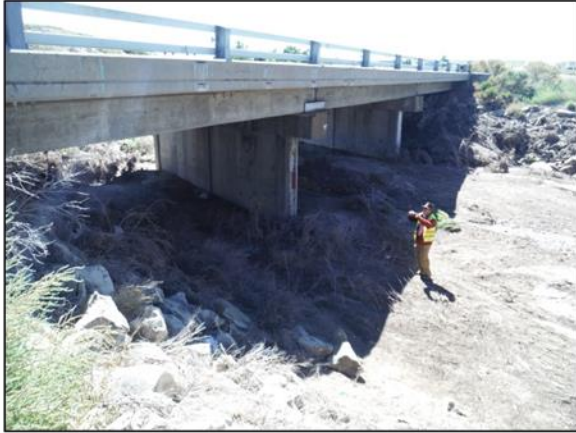
A-17-AC over Lone Tree Creek – Abutment riprap loss

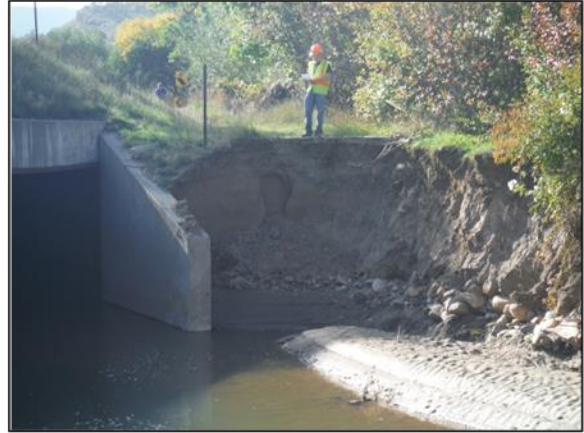
C-16-AF over Buckingham Ditch – Scour at downstream left abutment

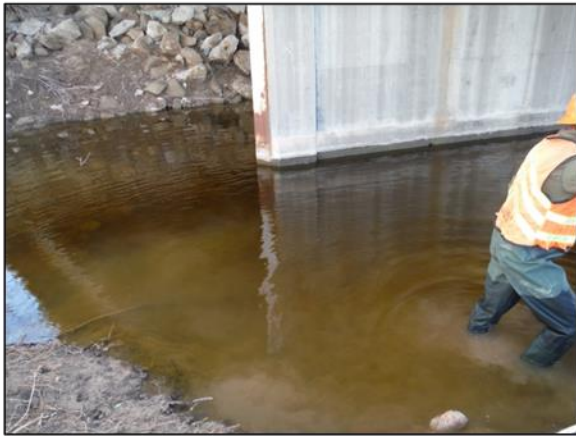
A-17-AC over Lone Tree Creek – Scour hole at left pier

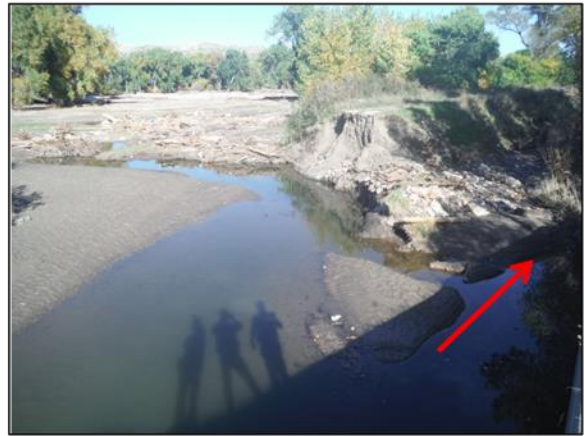
C-16-AF over Buckingham Ditch – The ditch berm or levee was washed out from Big Thompson overtopping

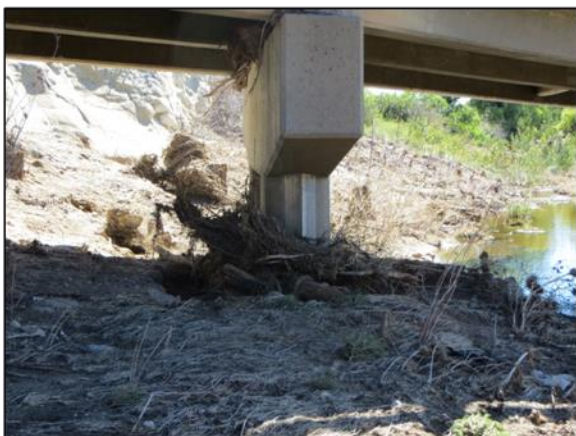
A-17-AC over Lone Tree Creek – Debris accumulation at pier

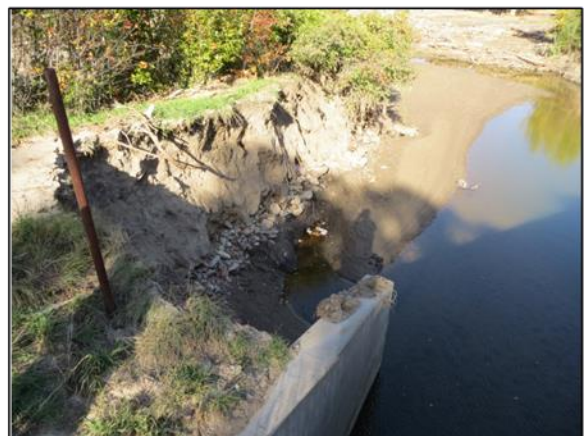
C-16-AF over Buckingham Ditch - Scour at downstream left abutment

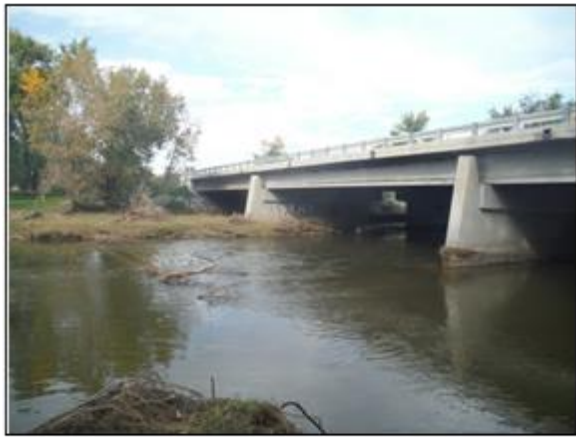
D-16-DA over Boulder Creek – Upstream face of bridge

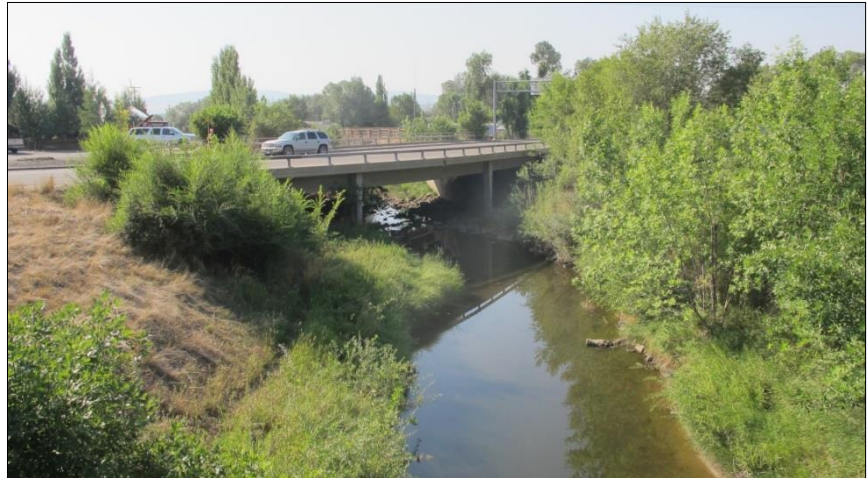
**Figure 1.** Bridge B-06-S over Fortification Creek

Bridge B-06-S is located in Moffat County on the U.S. Highway 40 mainline where it crosses Fortification Creek. Figure 1 shows Bridge B-06-S over Fortification Creek.

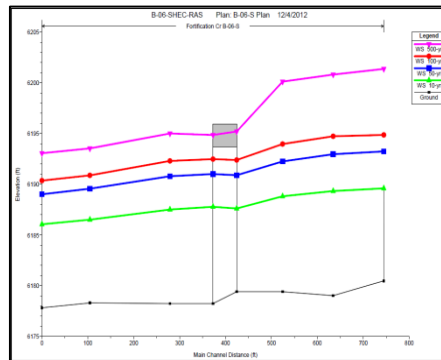
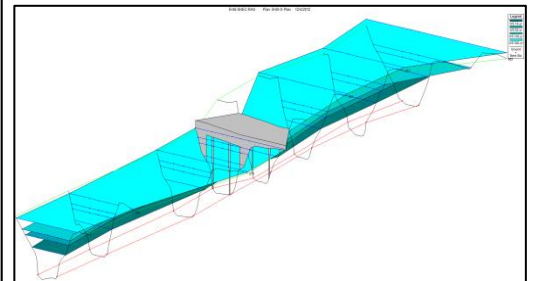
**Figure 2 (Left).** Water-surface profile showing the 10-, 50-, 100- and 500-year flows; **Figure 3 (Right).** 3D Plot of the reach around structure B-06-S

Hydrau-Tech, Inc. began the POA study of Bridge B-06-S by collecting site and structure information including hydrologic characteristics, GIS information and original bridge construction plans. Using this information, regional regression equations resulted in a 500-year flood discharge of 7510 cfs (cubic feet per second). After completing a survey of the reach upstream and downstream of the structure and analysis of sediment size, a HEC-RAS hydraulic model was developed. The model was used to estimate hydraulic conditions during the 500-year flow, including discharge distributions, velocity distributions, and water-surface profiles. Figure 2 shows the water-surface profile produced by the HEC-RAS hydraulic model. Figure 3 shows the reach-geometry plot produced by HEC-RAS.

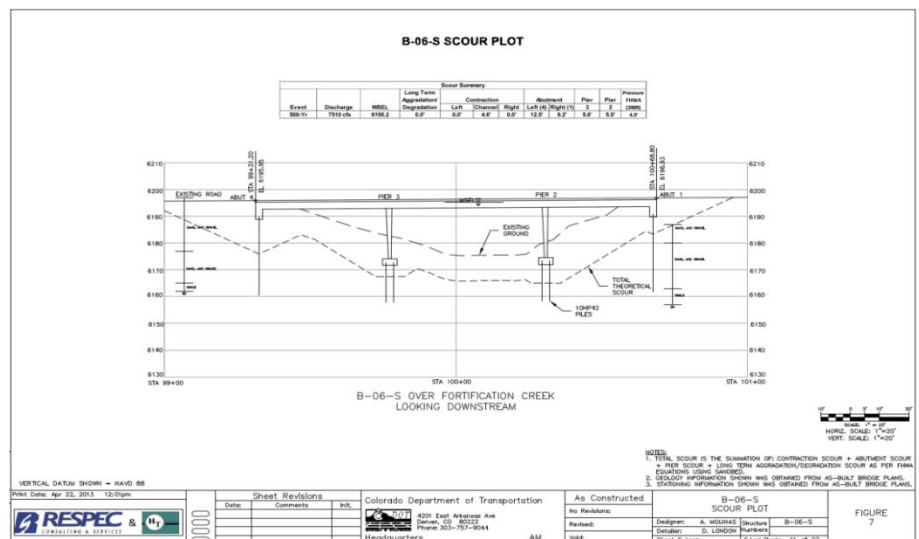
**Figure 4.** Scour plot generated in AutoCAD showing bridge geometry, foundation elevations, sediment boring-hole results and theoretical scour

Using results from hydraulic modeling, theoretical-scour estimates were calculated using FHWA's HEC-18 scour equations. AutoCAD drawings were produced with adjusted datum elevations and theoretical-scour lines in order to determine the stability of the structure under flood-scour conditions. Figure 4 shows a completed theoretical-scour plot created with AutoCAD, which shows foundation elevations and potential scour.

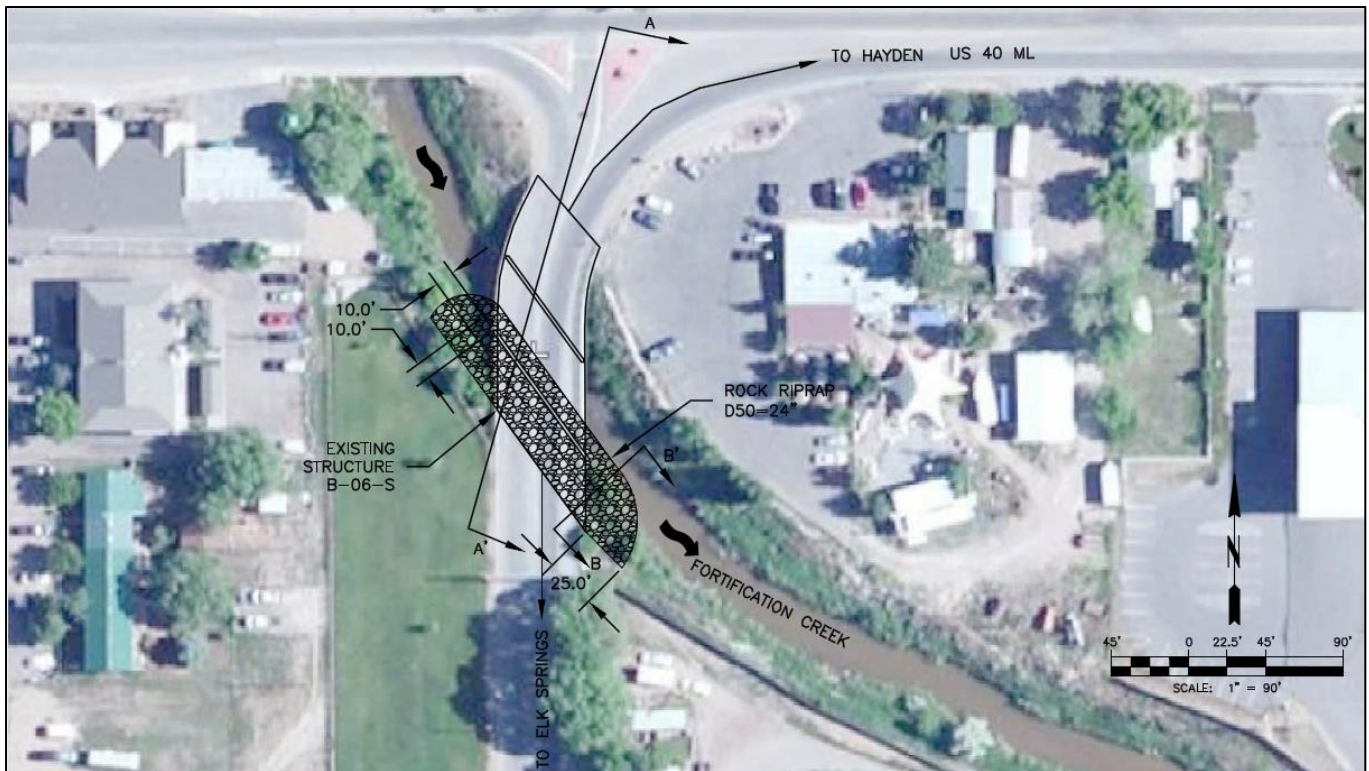
**Figure 5.** Plan view of Bridge B-06-S with recommended hydraulic-scour countermeasure locations

riprap protection, Hydraul-Tech, Inc. developed preliminary riprap countermeasures at critical locations on the bridge (right abutment and pier 2). Figure 5 is an aerial image of structure B-06-S with the recommended scour countermeasures. Figure 6 is a cross-sectional view of the structure with recommended scour-countermeasures and appropriate geometry. As a part of analysis, cost estimates for alternate countermeasures were created for comparison.

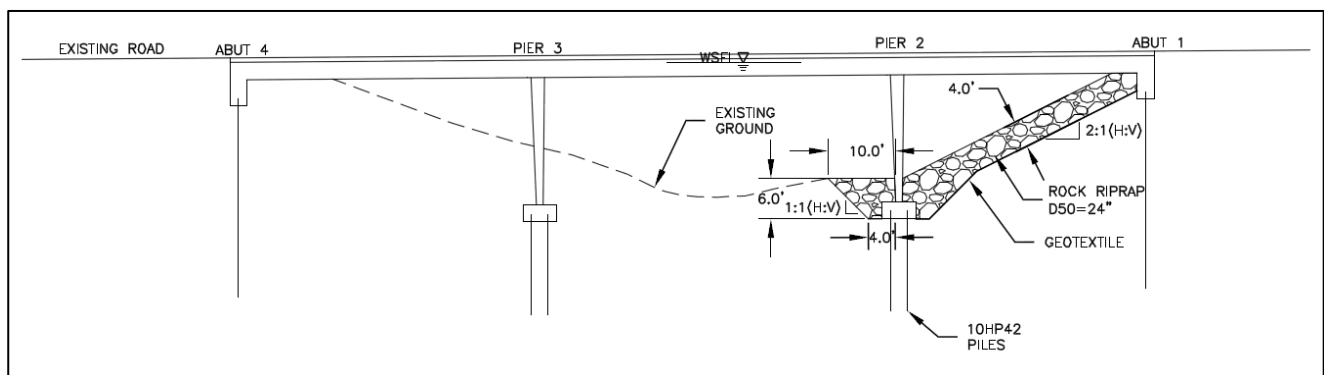
**Figure 6.** Cross-sectional view of Bridge B-06-S with recommended hydraulic-scour countermeasures

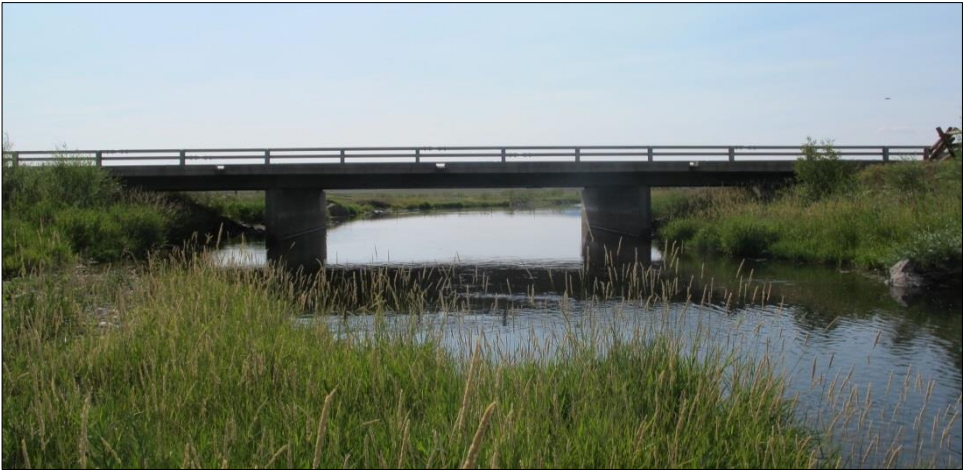
Figure 3. Bridge C-09-AR over Fortification Creek

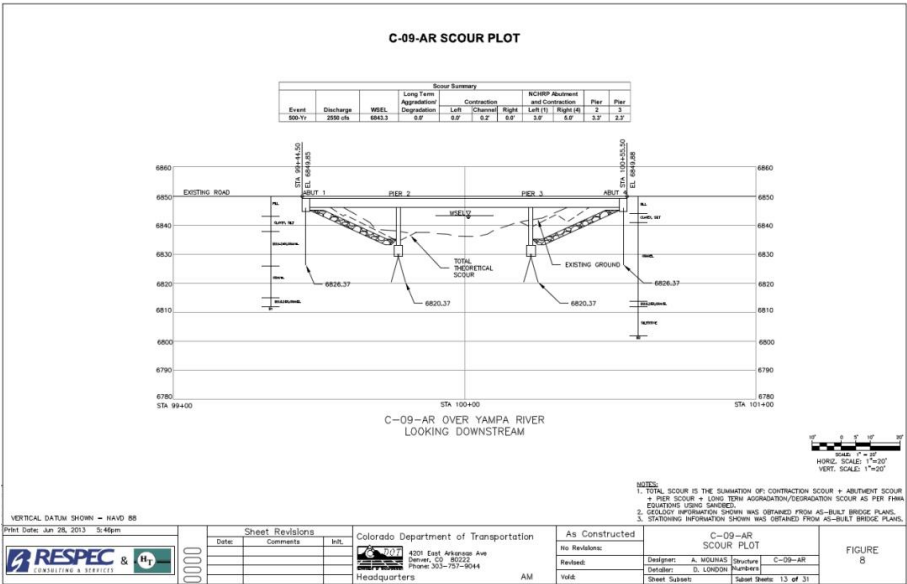
Figure 4. Scour plot generated in AutoCAD showing bridge geometry, foundation elevations, sediment boring-hole results and theoretical scour

Using results from hydraulic modeling, theoretical-scour estimates were calculated with FHWA's HEC-18 scour equations. AutoCAD drawings were produced with adjusted datum elevations and theoretical-scour lines in order to determine the stability of the structure under flood-scour conditions. Figure 4 is a theoretical-scour plot which shows foundation elevations and potential scour.

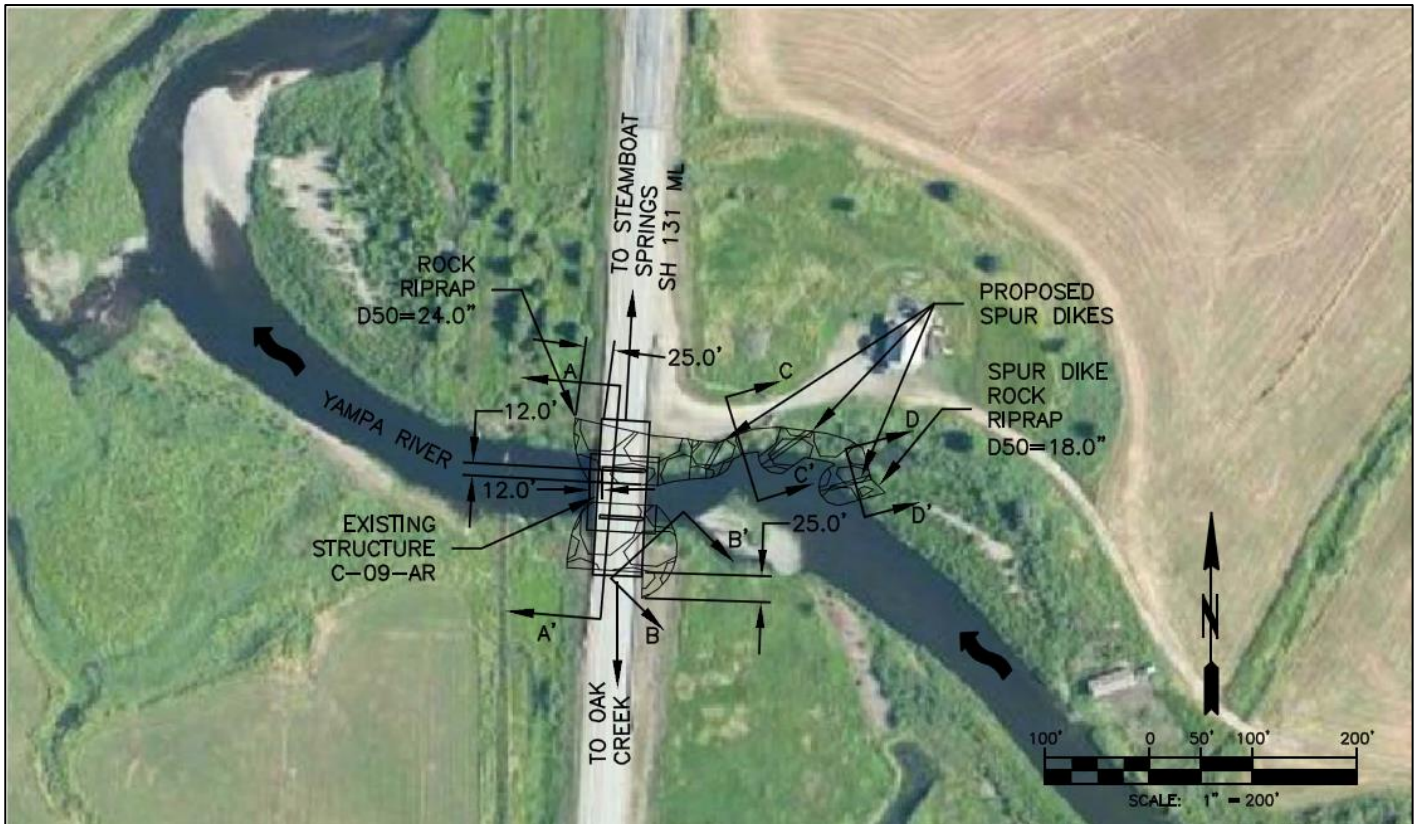
**Figure 5.** Plan view of Bridge C-09-AR with recommended hydraulic-scour countermeasure locations

riprap protection, Hydrau-Tech, Inc. developed preliminary riprap-countermeasures at critical locations on the bridge (right abutment and pier 2). Figure 5 shows an aerial image of structure C-09-AR with the recommended scour countermeasures. Figure 6 is a cross-sectional view of the structure with recommended scour countermeasures and appropriate geometry. As a part of analysis, cost estimates for alternate countermeasures were created for comparison.

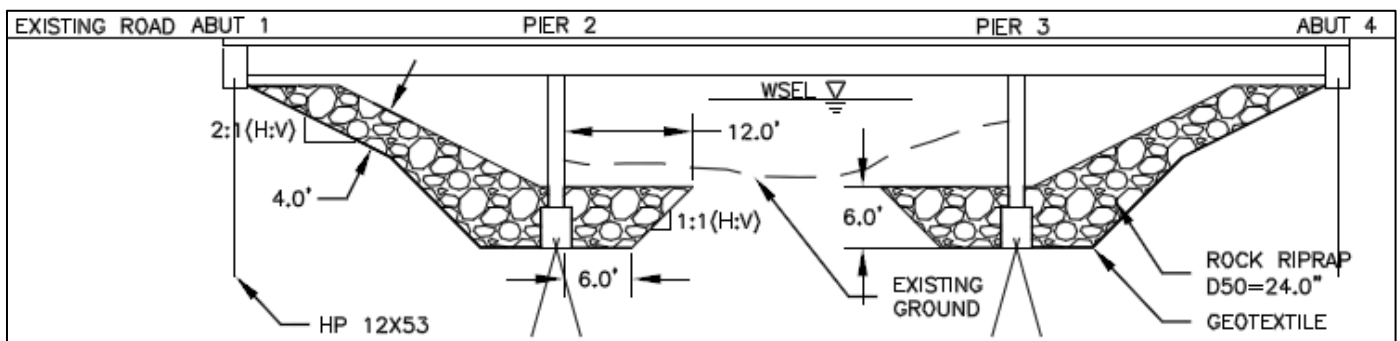
**Figure 6.** Cross-sectional view of Bridge C-09-AR with recommended hydraulic-scour countermeasures

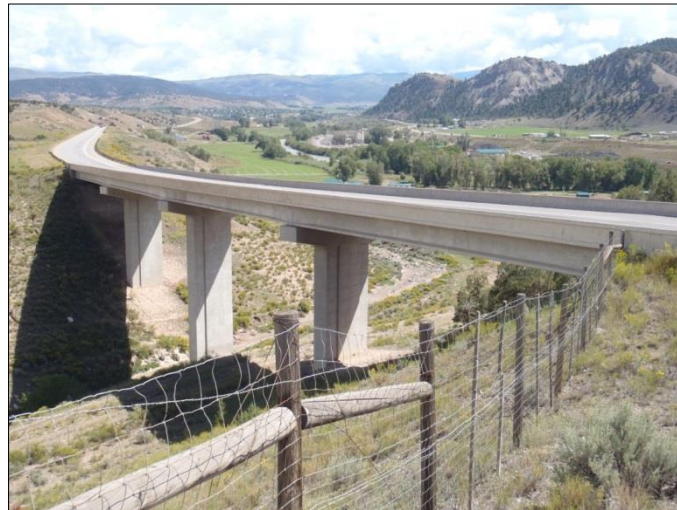
Figure 5. Bridge F-09-AF over Cottonwood Creek

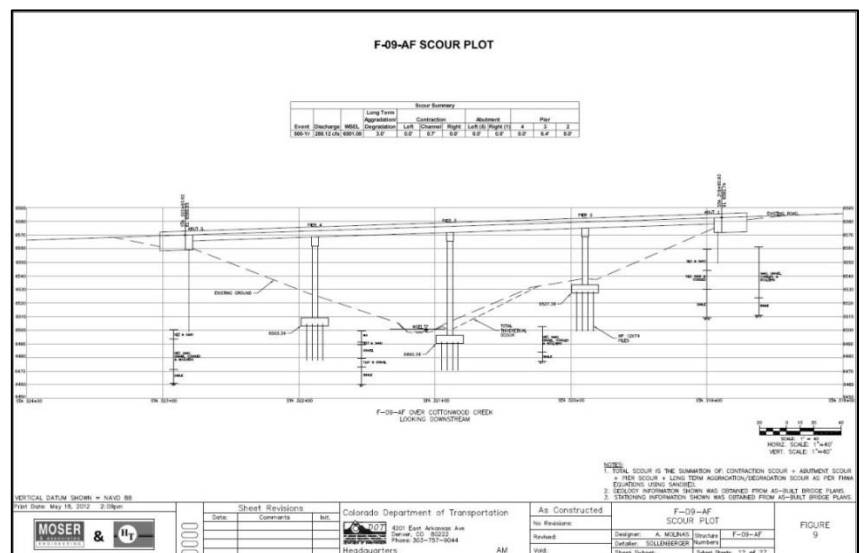
Figure 4. Scour plot generated in AutoCAD showing bridge geometry, foundation elevations, sediment bore-hole results and theoretical scour

Using results from hydraulic modeling, theoretical-scour estimates were calculated with FHWA's HEC-18 scour equations. AutoCAD drawings were produced with adjusted datum elevations and theoretical-scour lines in order to determine the stability of the structure under flood-scour conditions. Figure 4 shows a completed theoretical-scour plot crested with AutoCAD, showing foundation elevations and potential scour.

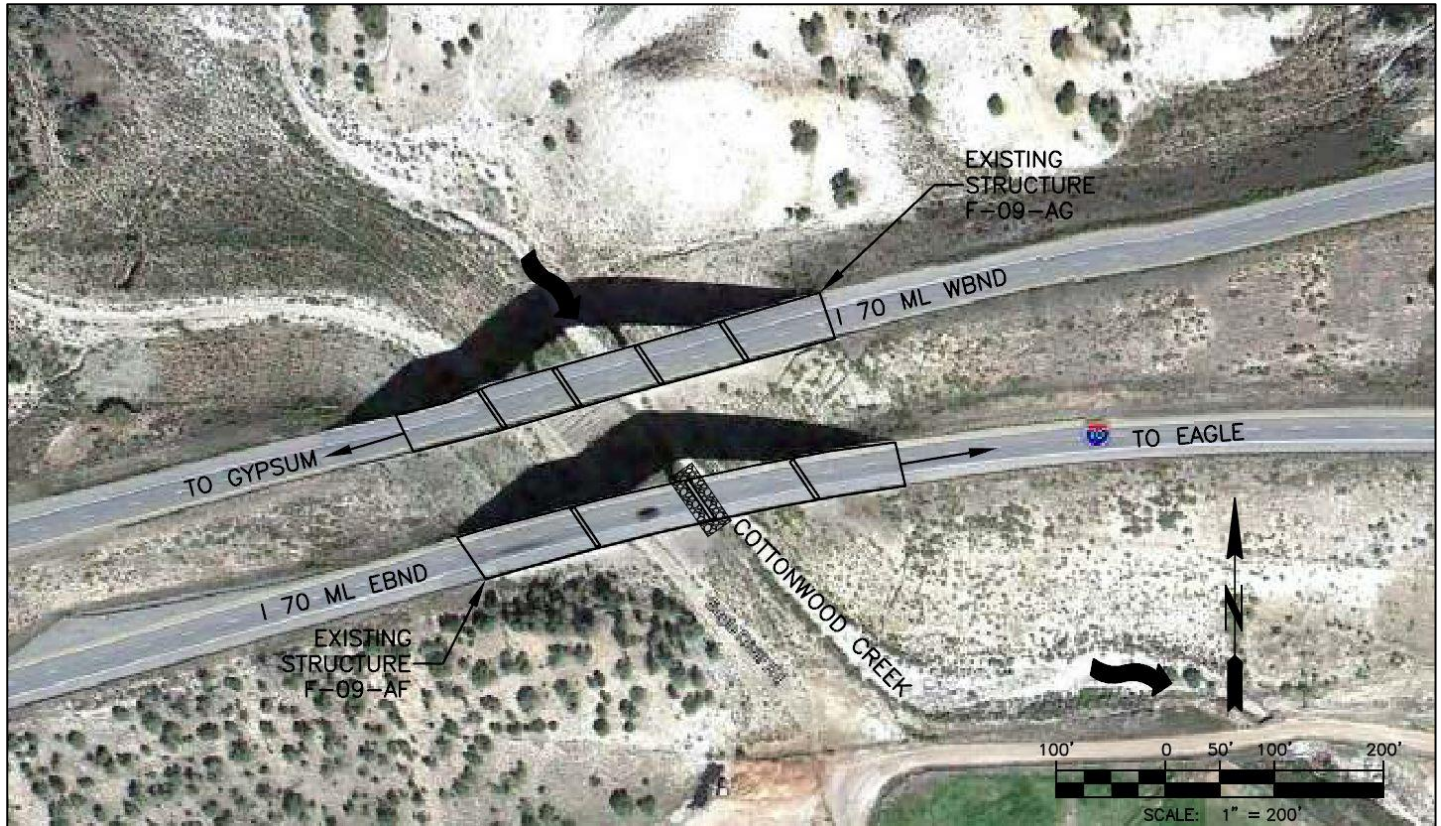
**Figure 5.** Plan view of Bridge F-09-AF with recommended hydraulic-scour countermeasure locations

riprap protection, Hydrau-Tech, Inc. developed preliminary riprap-countermeasures at the critical location on the bridge (pier 3). Figure 5 is an aerial image of structure F-09-AF with the recommended scour countermeasure. Figure 6 is a cross-sectional view of the structure with the recommended scour countermeasure and appropriate geometry. As a part of analysis, cost estimates for alternate countermeasures were created for comparison.

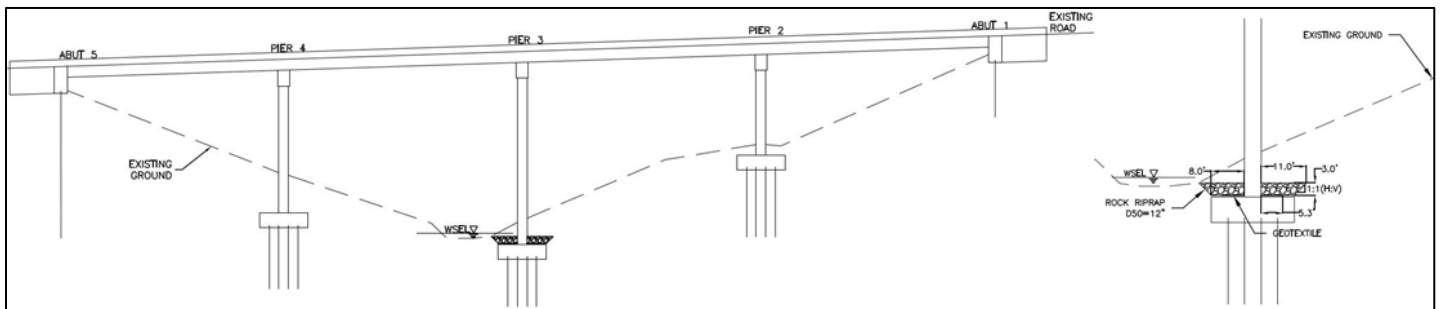
**Figure 6.** Cross-sectional view of Bridge F-09-AF with recommended hydraulic-scour countermeasures (left) and detail of pier protection (right)

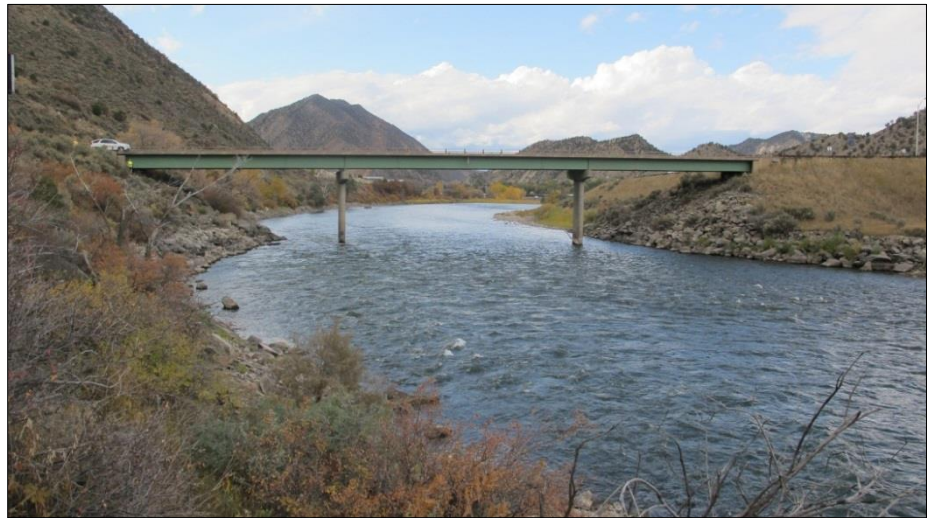
Bridge F-06-M is located in Garfield County on the Interstate 70 access road where it crosses the Colorado River. Figure 1 shows Bridge F-06-M over the Colorado River.

Figure 7. Bridge F-06-M over the Colorado River

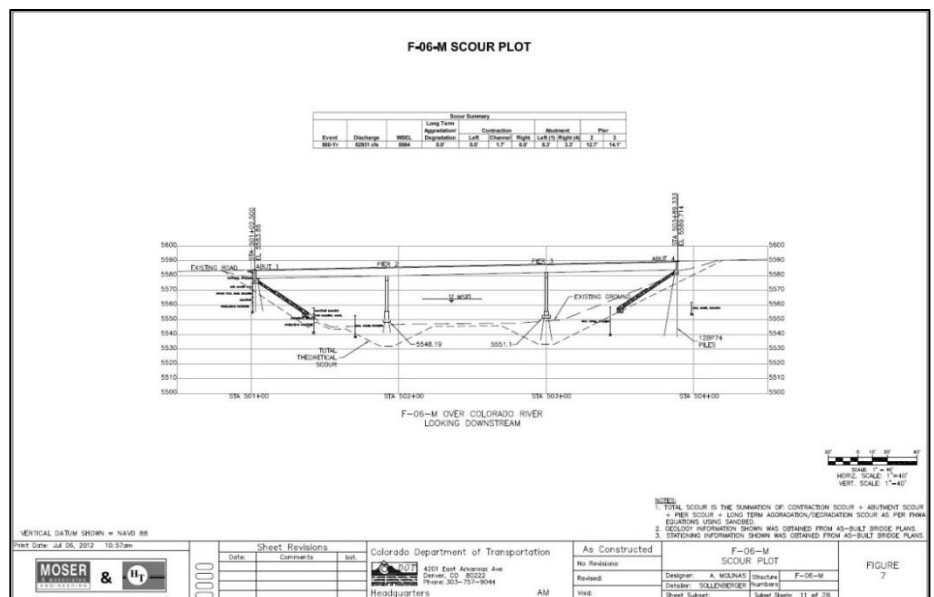
Using the results from hydraulic modeling, theoretical scour estimates were calculated with FHWA's HEC-18 scour equations. AutoCAD drawings were produced with adjusted datum elevations and theoretical-scour lines in order to determine the stability of the structure under flood-scour conditions. Figure 4 shows a completed theoretical-scour plot created with AutoCAD, showing foundation elevations and potential scour.

Figure 3. Scour plot generated in AutoCAD showing bridge geometry, foundation elevations, sediment bore-hole results and theoretical scour

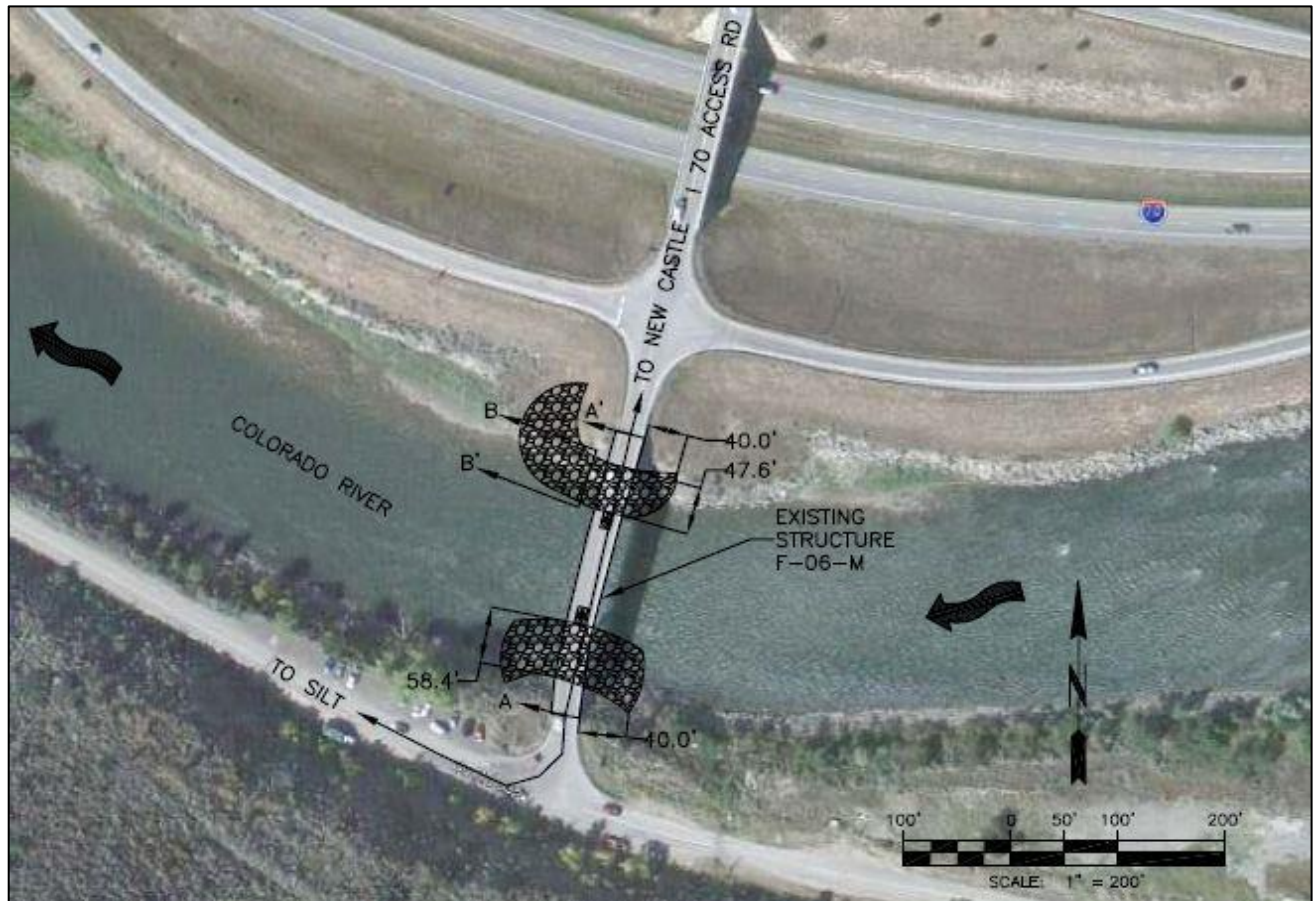
riprap protection, Hydraul-Tech, Inc. developed preliminary riprap-countermeasures at the critical locations on the bridge (right abutment and pier 2). Figure 5 is an aerial image of structure F-06-M with the recommended scour countermeasures. Figure 6 is a cross-sectional view of the structure with the recommended scour countermeasures and appropriate geometry. As a part of analysis, cost estimates for alternate countermeasures were created for comparison.

**Figure 5.** Plan view of Bridge F-06-M with recommended hydraulic-scour countermeasure locations

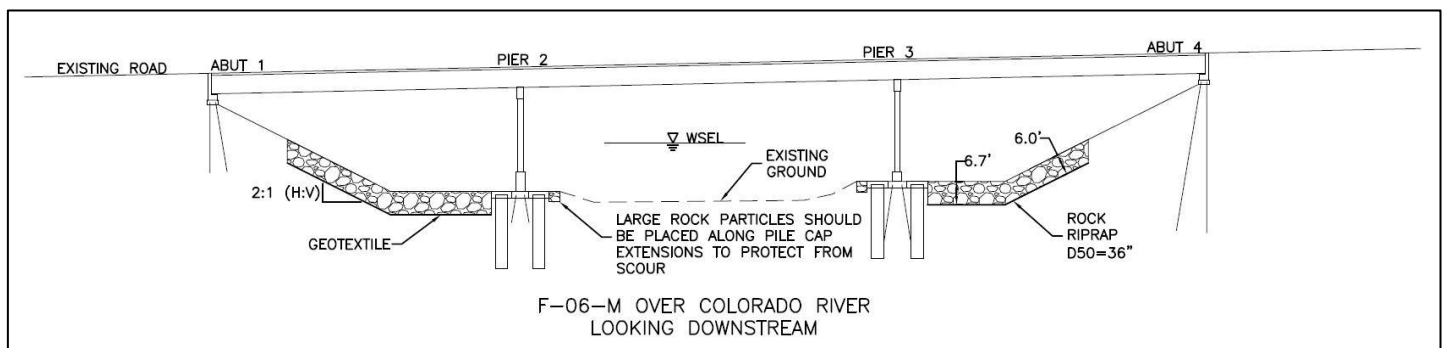
**Figure 6.** Cross-sectional view of Bridge F-06-M with recommended hydraulic-scour countermeasures

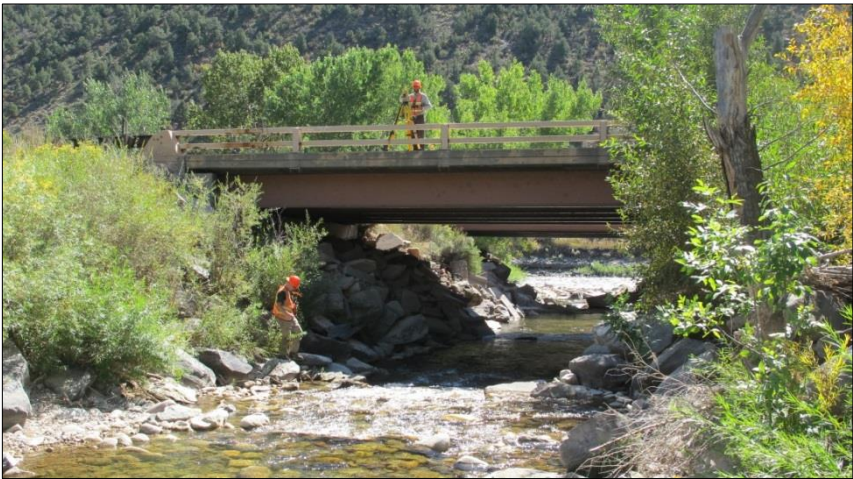
Figure 9. Bridges F-06-O and F-06-P over Elk Creek
