# Hydrau-Tech, Inc.

# HYDRAU-TECH, INC.

## 2013 COLORADO FLOOD EMERGENCY HYDRAULIC RESPONSE

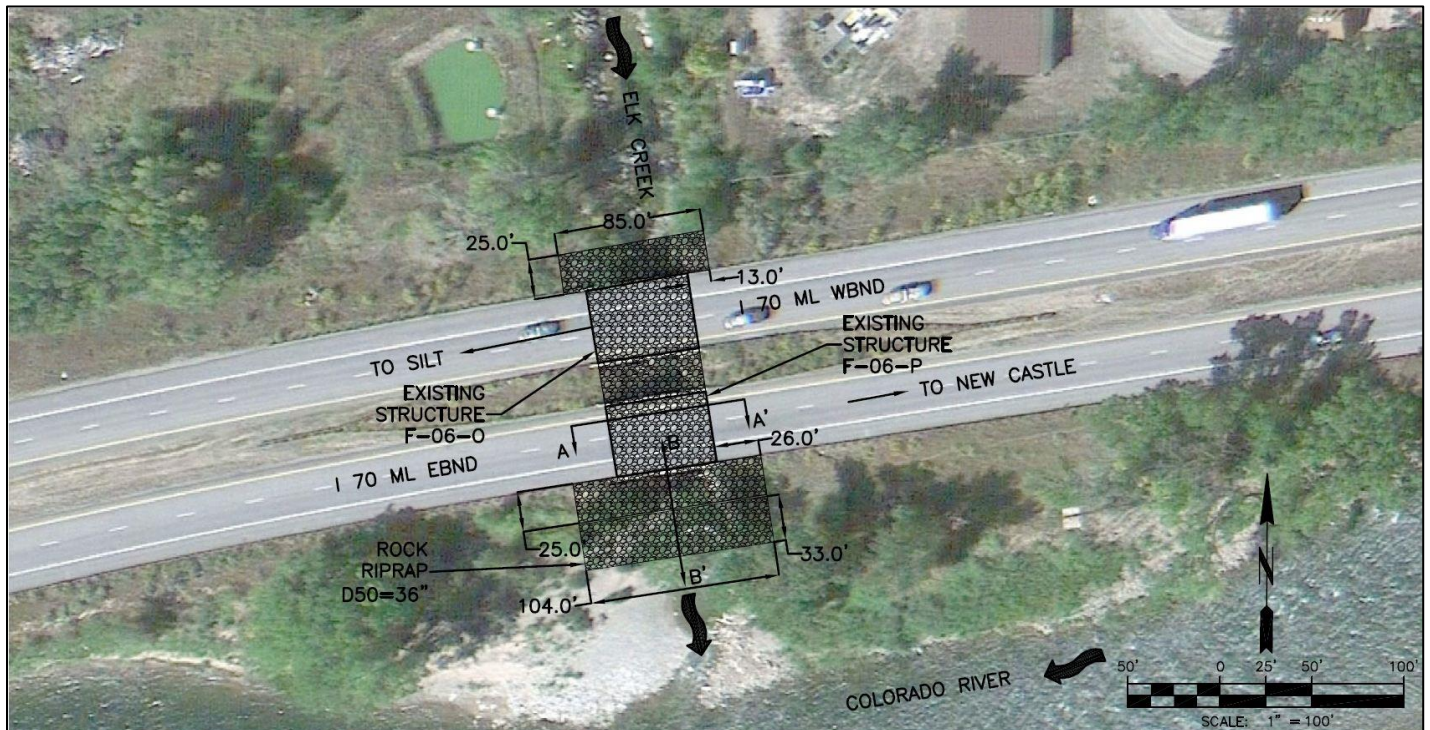
Tech, Inc. developed preliminary riprap-countermeasures at the critical locations on the bridge (right abutment and pier 2). Figure 5 is an aerial image of structures F-06-O and F-06-P with the recommended scour countermeasures. Figure 6 is a cross-sectional view of the structure with the recommended scour countermeasures and appropriate geometry. As a part of analysis, cost estimates for alternate countermeasures were created for comparison.

**Figure 5.** Plan view of Bridges F-06-O and F-06-P with recommended hydraulic-scour countermeasure locations

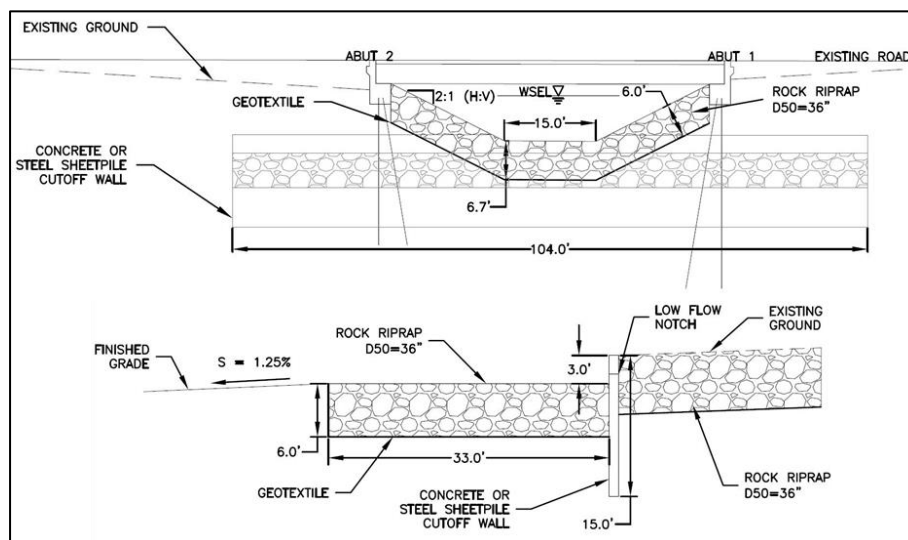
**Figure 6.** Cross-sectional view of recommended hydraulic scour countermeasures at Bridges F-06-O and F-06-P (above) and a profile view of the downstream drop structure (below)

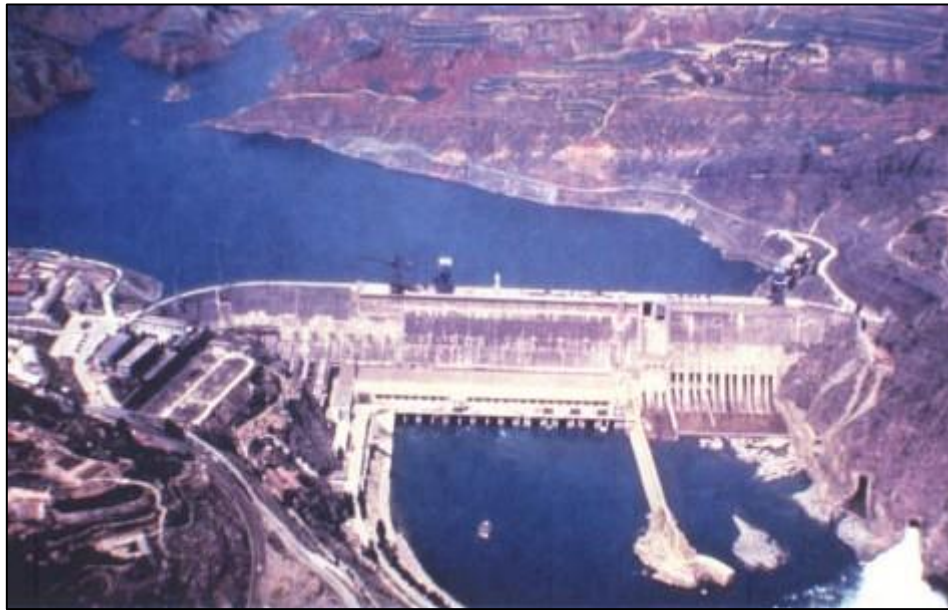
Sanmenxia Reservoir is located in the lower part of the Middle Yellow River in China. It is a multi-purpose hydro-project, primarily used for flood control. Figure 1 shows the Sanmenxia Dam and its reservoir with one of its downstream outlets in operation. In this World Bank project, numerical

**Figure 1.** View of Sanmenxia Dam and its reservoir

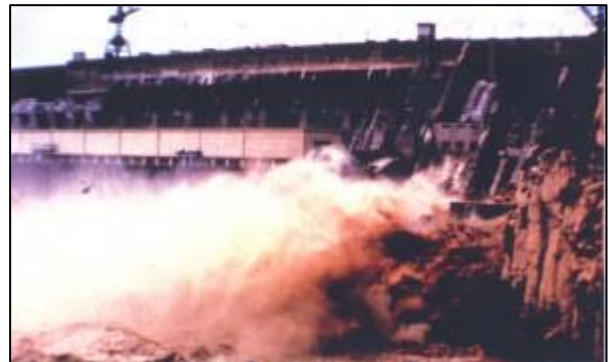
**Figure 3.** Sediment-flushing operation through Sanmenxia dam releases up to 90% of solids.

The drainage area above the dam is 688,000 km<sup>2</sup>. The Yellow River cuts through an extensive loess plateau where a 439,000-km<sup>2</sup> portion of it suffers from severe soil erosion (Figure 2). The channel flows carry up to 60% solids by weight, consisting mainly of fine sands and silts. Due to the large quantity of sediment carried by the Yellow River, Sanmenxia Reservoir was filled with sediment within a few years after its completion. Through sediment flushing during flooding season, the useful life of the reservoir was extended (Figure 3).

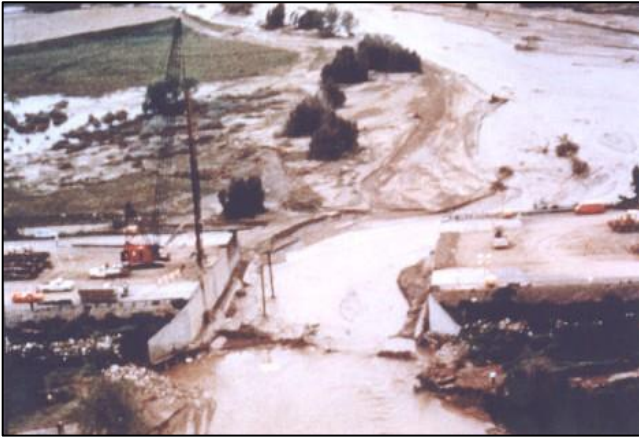
The Interstate 5 bridge that collapsed near Coalinga, California in 1998 carried up to 25,000 vehicles per day over Arroyo Pasajero Creek. Caltrans officials say they may never know why the bridge collapsed, but they have suggested two possible scenarios. In the first scenario, the water was so high and fast that it swept the bridge off its foundations. In the second, intense flow scoured the bed below the pilings and knocked the foundation out from under the bridge. The bridge was built in 1967 and was 120-feet long and 40-feet wide. Pilings were 12- feet deep. Figures 1 through 3 show the failed bridge.

**Figure 1.** View of the failed bridge looking upstream.

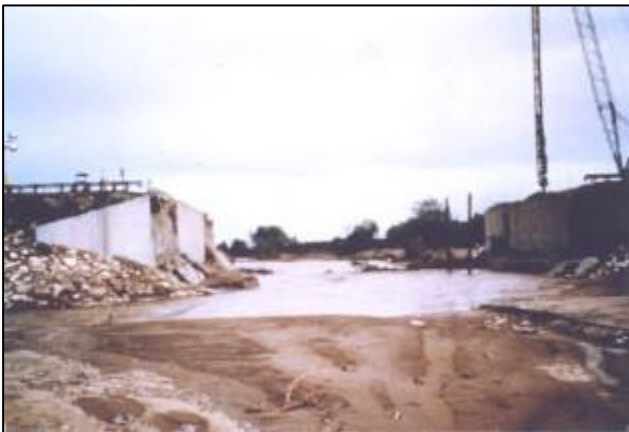
**Figure 2.** View of the failed bridge from the channel facing downstream. Note the failed left abutment.

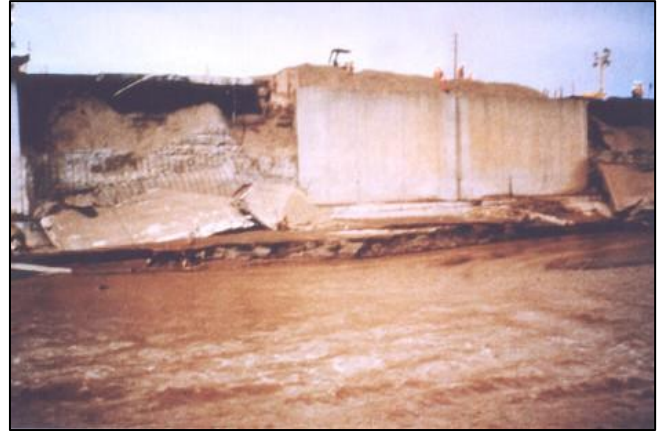
**Figure 3.** View of the failed bridge from the channel facing downstream. Note the failed left abutment.

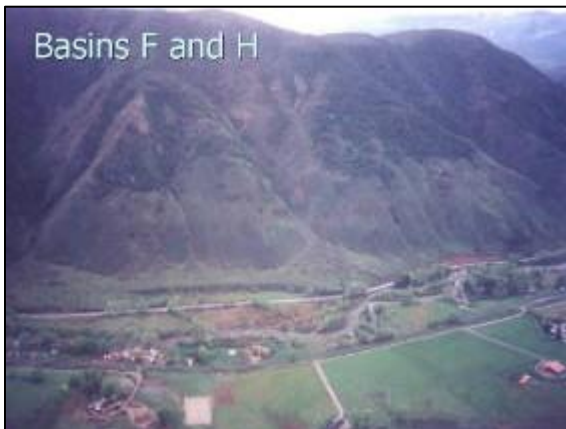
**Figure 2.** Debris flow fans along Colorado State Highway 82

In this Colorado Department of Transportation project, large debris-flow culverts were designed crossing a new four-lane section of State Highway 82 near Aspen, Colorado. Along the project site, the highway passes through Snowmass Canyon along a series of small debris-producing watersheds shown in Figures 1 and 2.

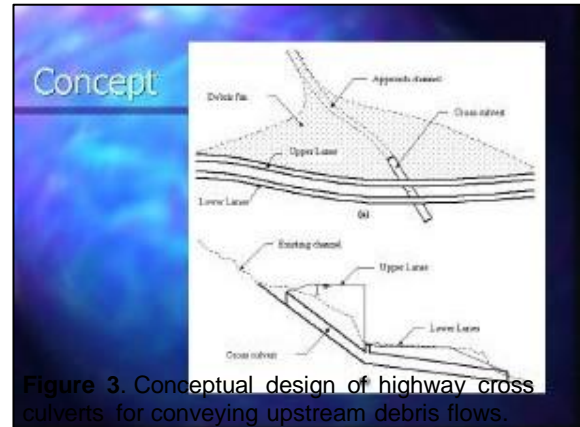
**Figure 3.** Conceptual design of highway cross culverts for conveying upstream debris flows.

In order to widen the existing two-lane highway to four lanes along the narrow canyon, a split configuration was utilized. Space for the additional two lanes going from Glenwood Springs to Aspen was created by encroaching on the canyon wall. This included building a retaining wall and elevating the upper lanes as much as 30 feet. At 8 locations along the path, basins producing debris fans border the highway. Potential debris flowing from these basins is passed beneath the highway without interrupting traffic, as shown in Figure 3. Figure 4 shows the computed debris-flow profiles for one of the basins.

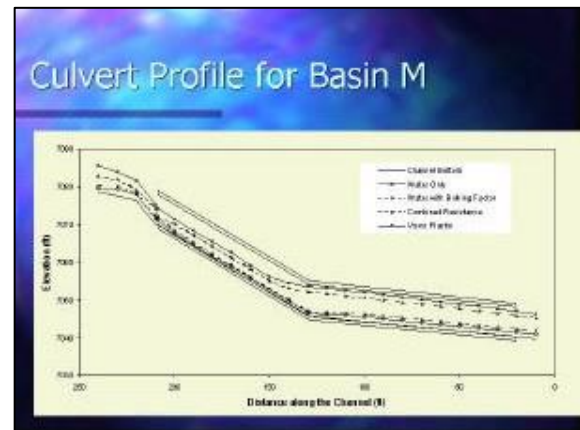
**Figure 4.** Computed debris flow profiles along with profiles computed using only water, and bulked discharges

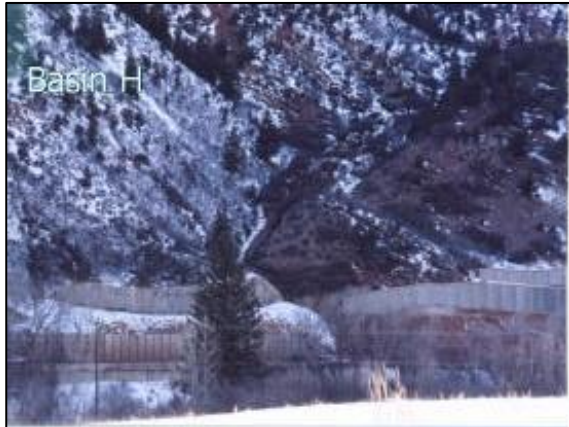
**Figure 5.** Elevated segment of State Highway 82 crosses a debris fan at the base of Basin H

Figures 5 and 6 show the elevated section of highway cutting through a debris fan at the base of Basin H.

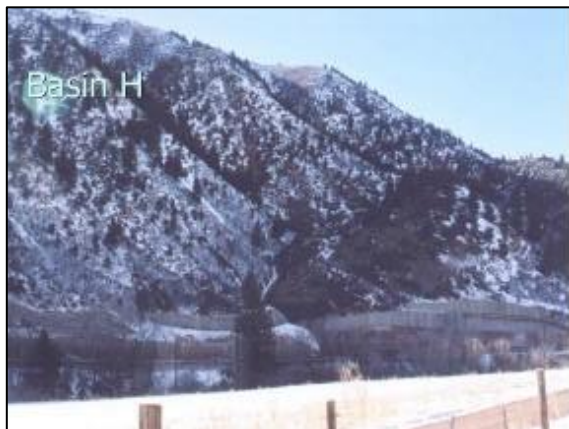
**Figure 6.** State Highway 82 crossing debris-basin H

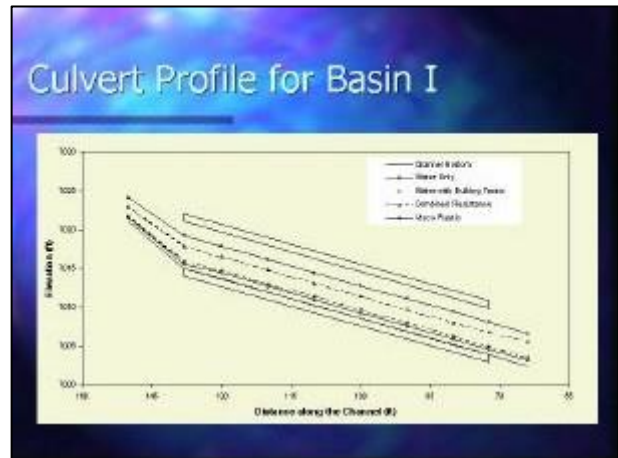
Figure 7 shows a culvert design for the watershed identified as Basin I. It does not require a break in the invert slope due to the location of the crossing. The cast-in-place culvert outlet and typical sections, as well as the construction of elevated sections of the highway, are shown in Figures 8 and 9.

**Figure 7.** Computed debris flow profiles for Basin I

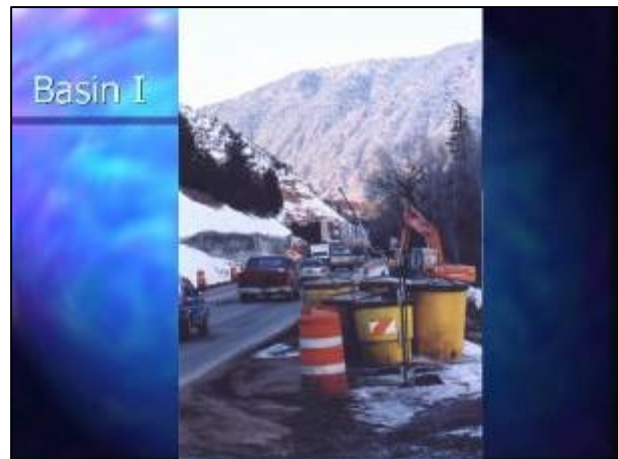
**Figure 8.** Construction of upper lanes at Basin I

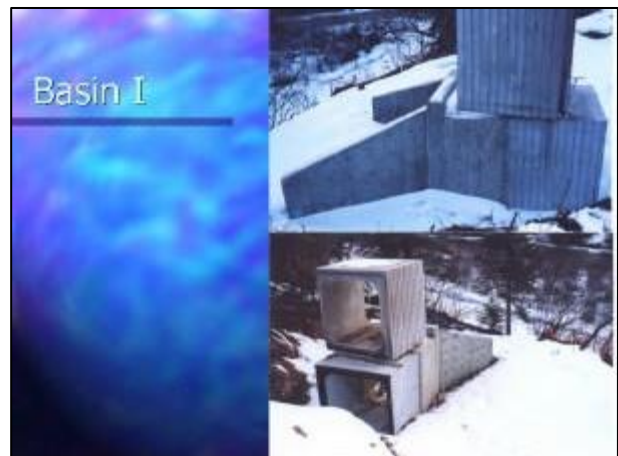
**Figure 9.** Culvert outlet and pre-fabricated culvert sections
